Fig. 1a Bath stability tests in APM
(1:5:20/1:1:200); 70-75°C, 60min., Bis Tris (0.195 w %)

Fig.2: Cleaning results with different SC-1 mixtures referring to surface contaminations by Fe, Al, Zn and Ca

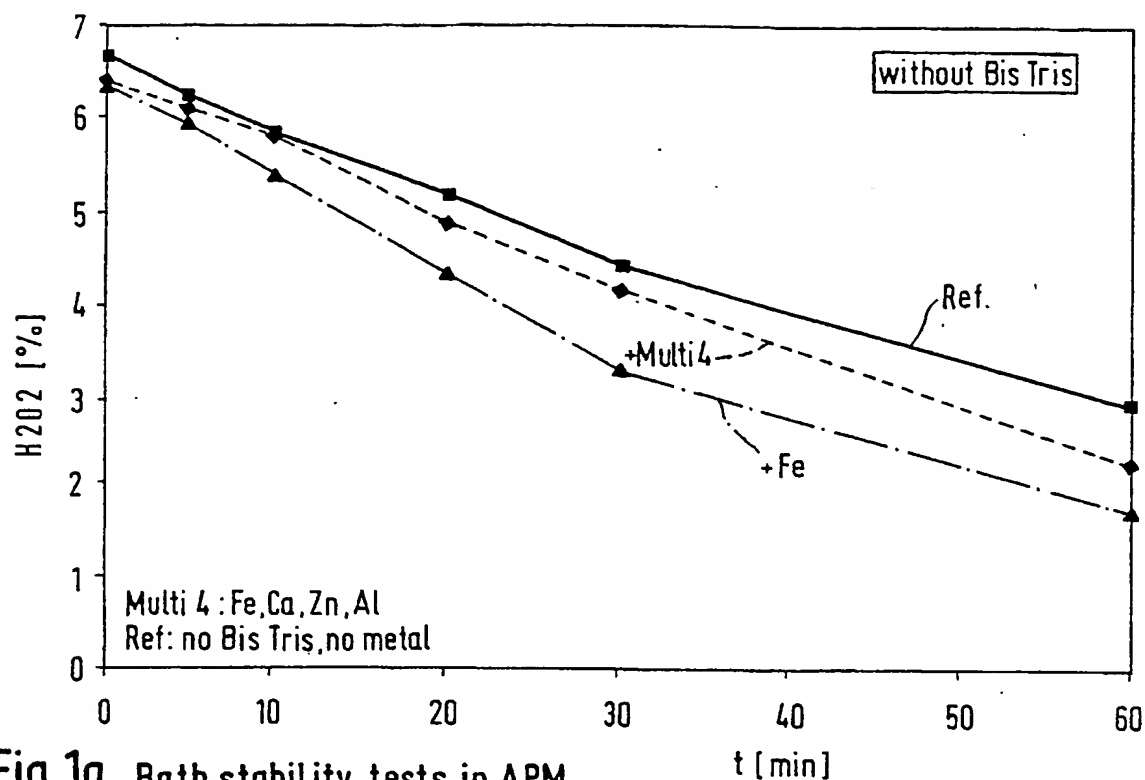
Decomposition of H₂O₂ in APM without/with (1:5:20) Bis Tris and
decomposition of H₂O₂ in APM without/with (1:1:200) Bis Tris

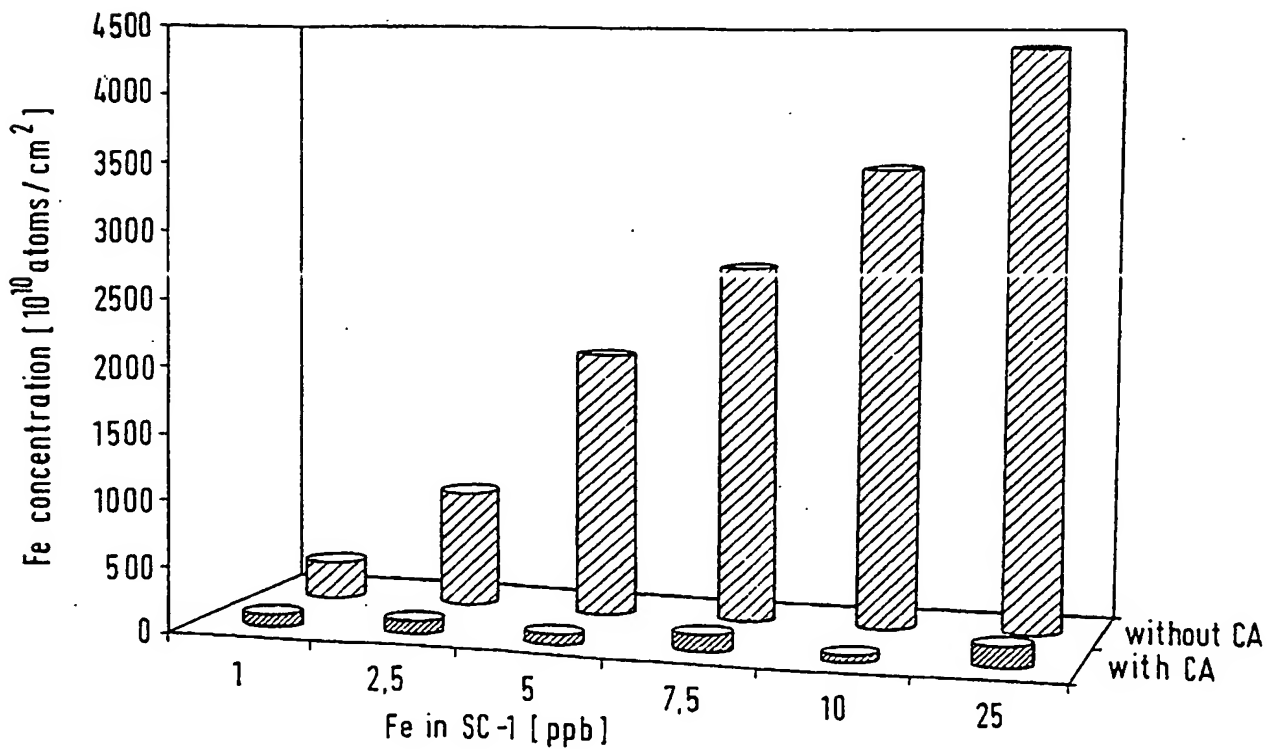
Fig.3 Comparison: Fe concentration after SC-1 with/without CA

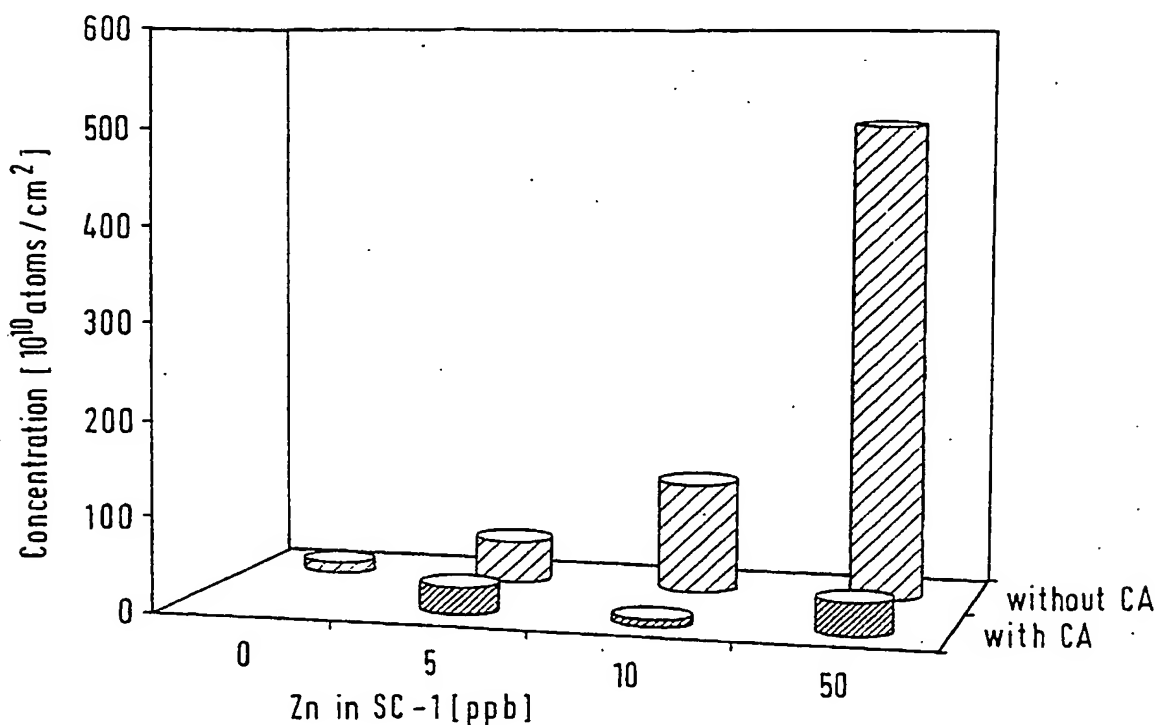
Fig.5

Comparison: Zn concentration after SC-1 with/without CA

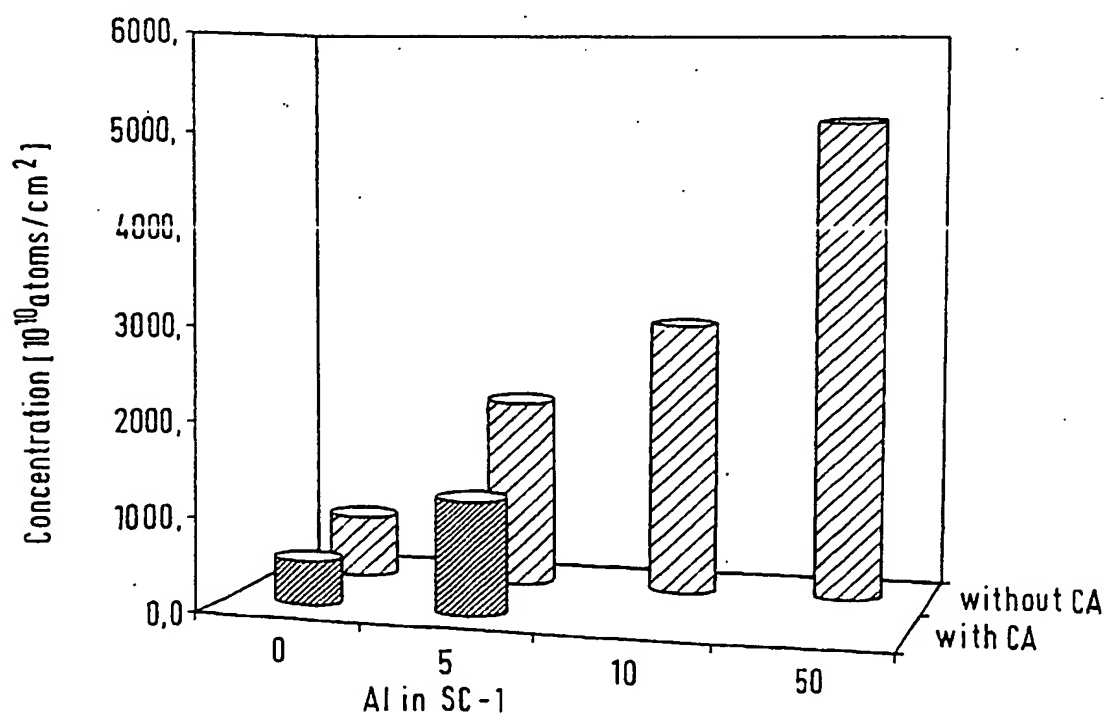
**Fig.6**

Comparison: Al concentration after SC-1 with/without CA

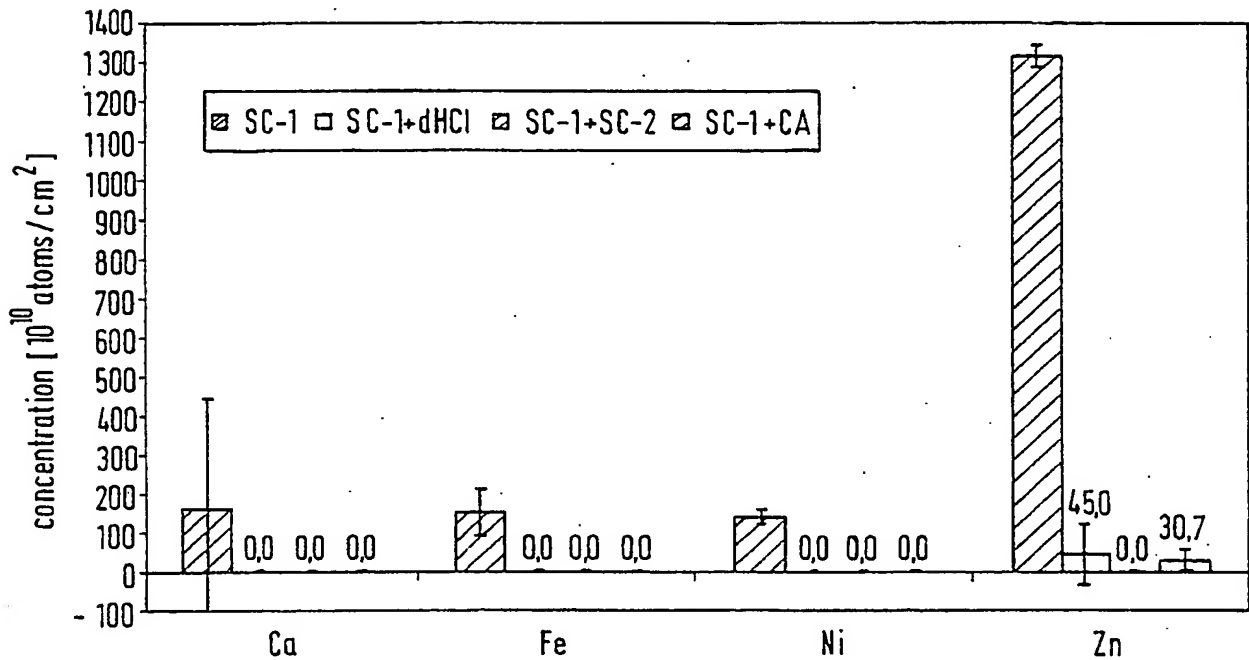
Fig. 7

Comparison: SC-1 vs. SC-1+dHCl vs. SC-1+SC-2 vs. SC-1+CA

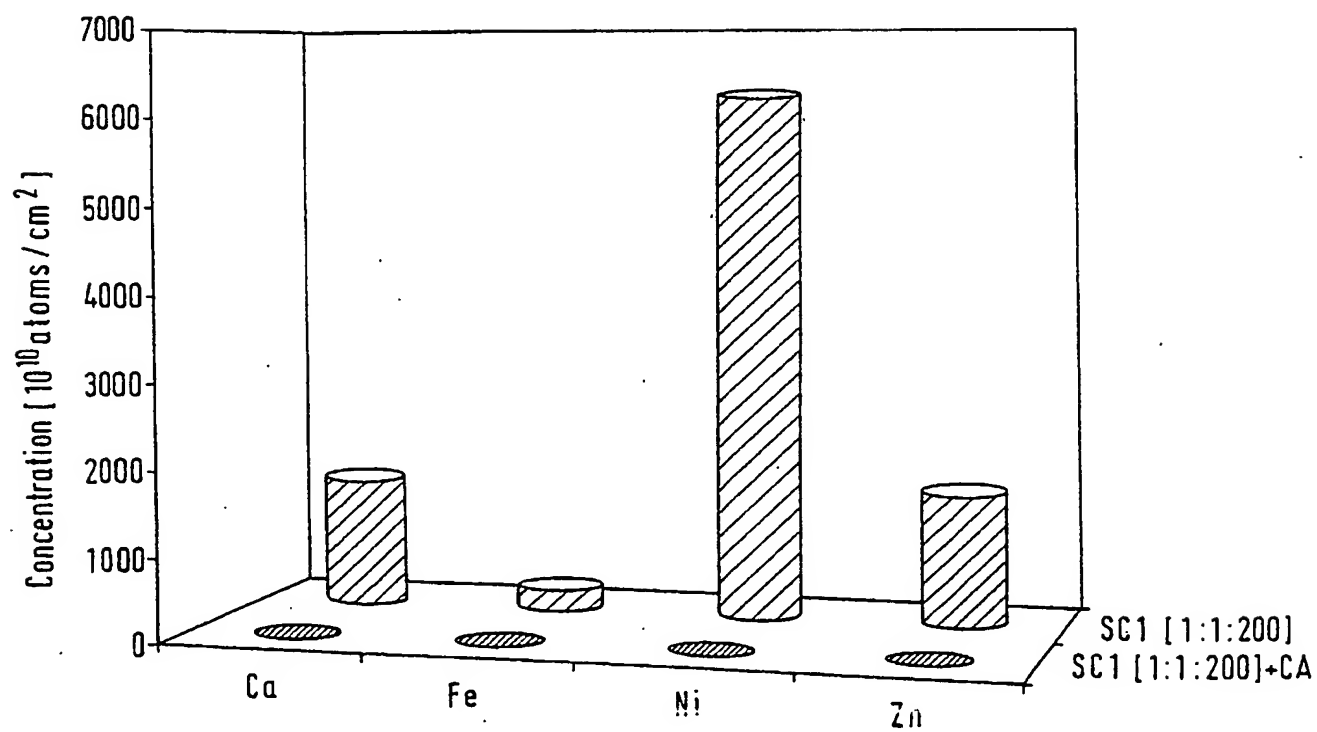
Fig.9

Comparison: SC-1 [1:1:200] with and without

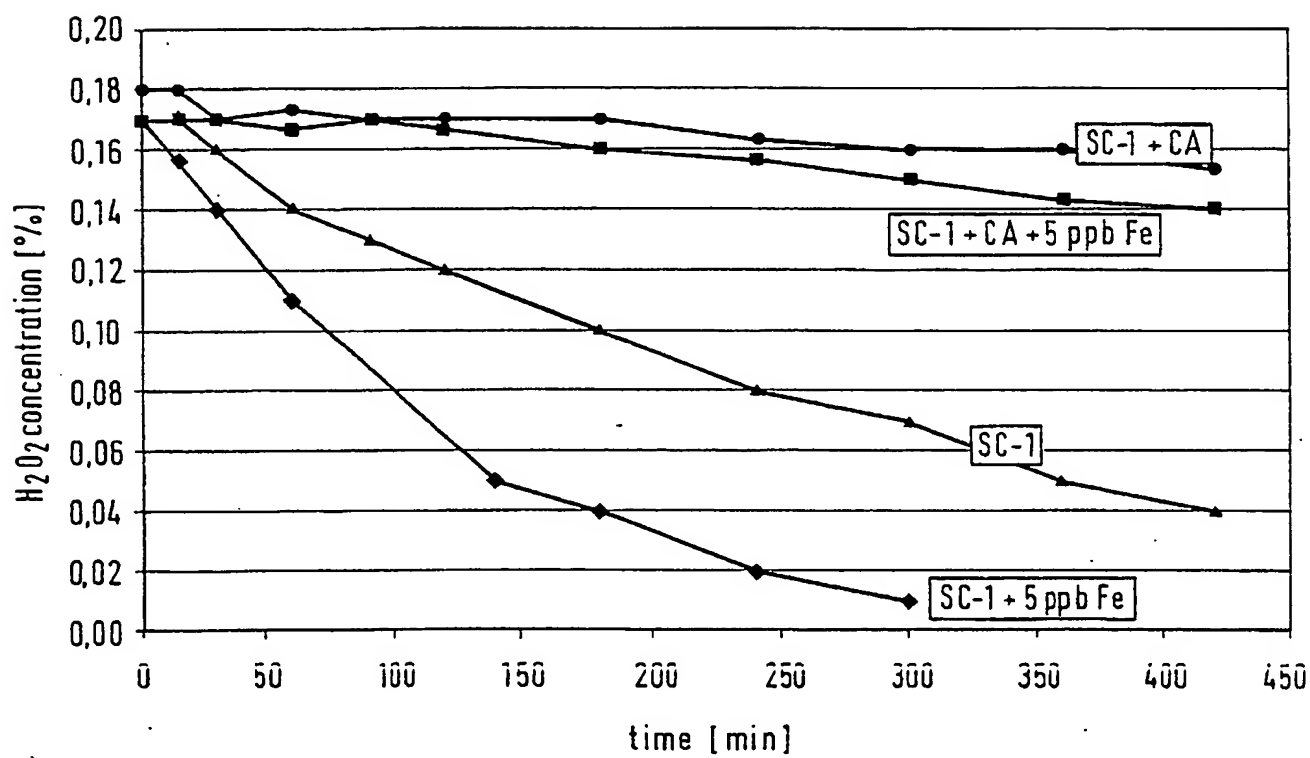
Fig.10

Decomposition of H_2O_2 in SC-1 [1:1:200]@ 70-75°C

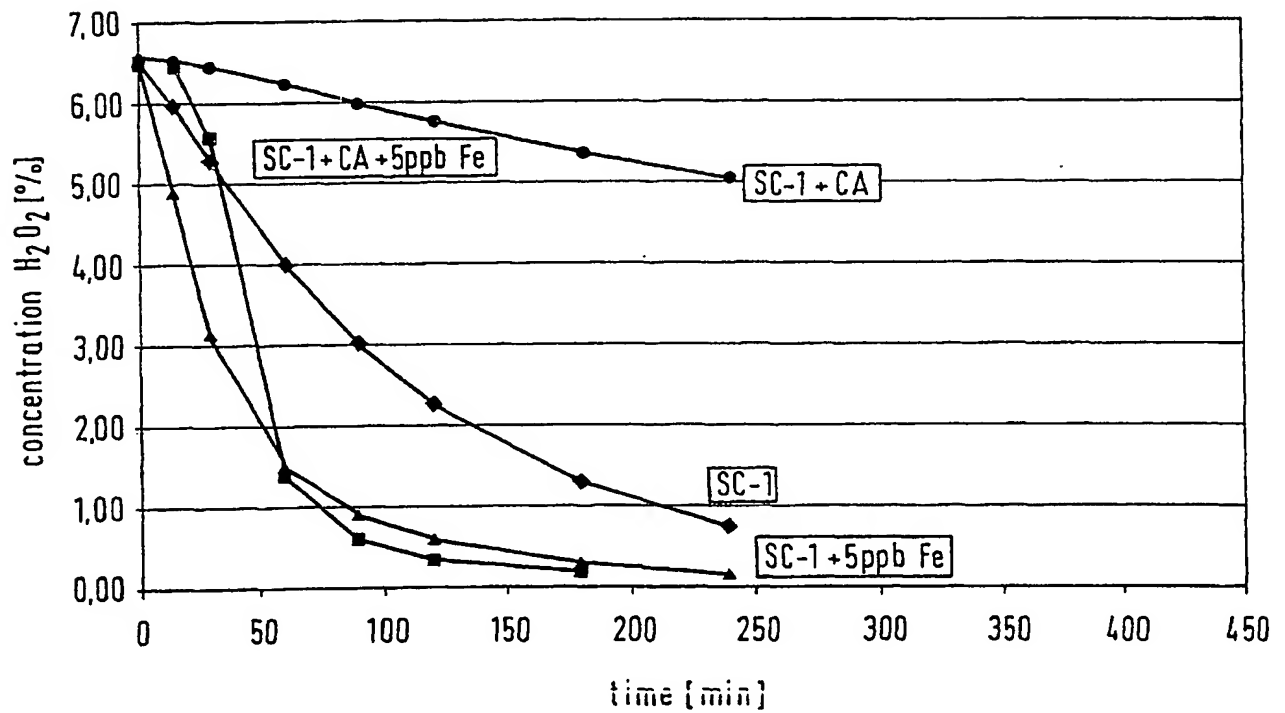
Fig.11

Decomposition of H_2O_2 in SC-1 [1:5:20] @ 70-75°C
